Nathan Eckstein Middle School Window Replacement

Landmark Preservation Board
Marc A. Tegen, Project Manager

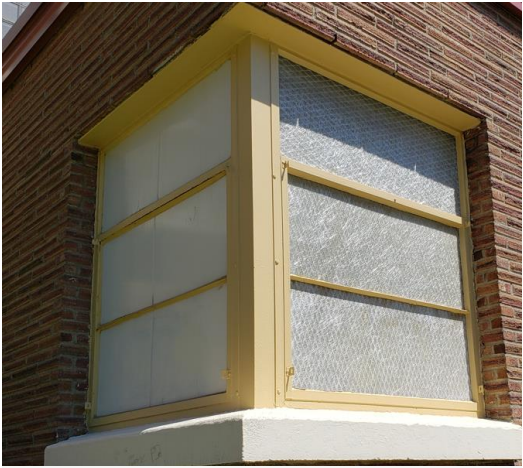
Glass on the left, fiberglass on the right

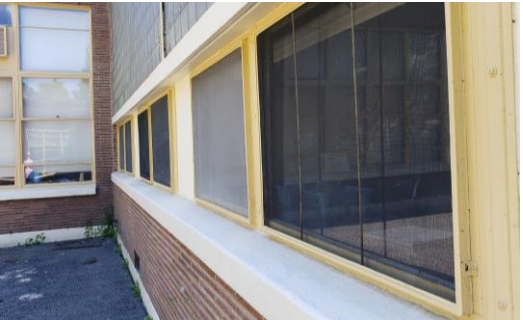
Window screens over glass

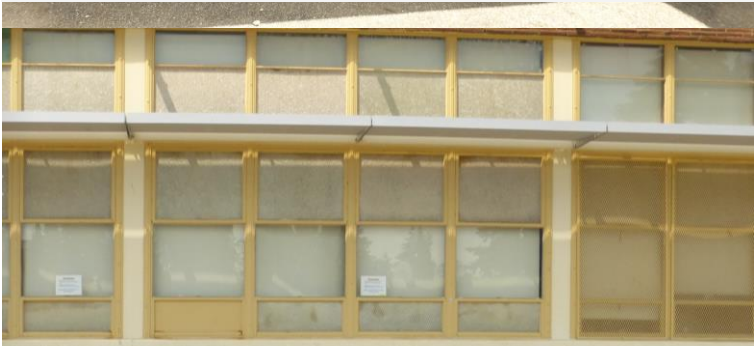
Variety of glass colors and types of fiberglass

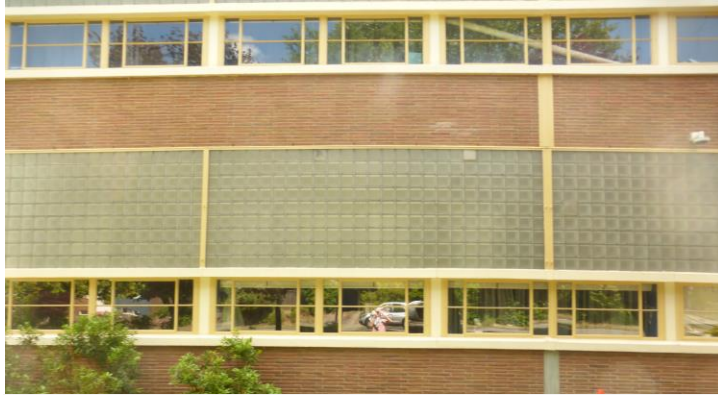
Classroom windows with combination in-swing hopper and fixed sides

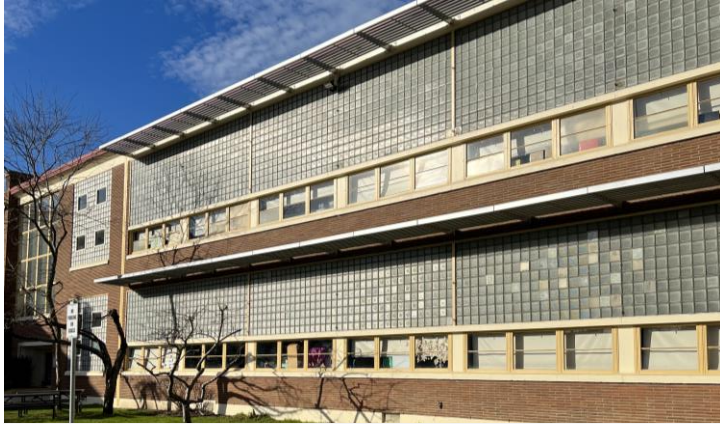
Classroom in-swing hopper windows

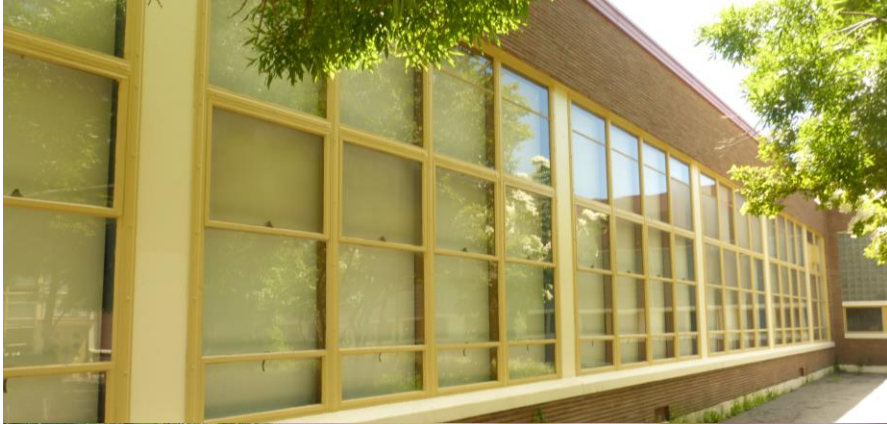
Typical shop windows

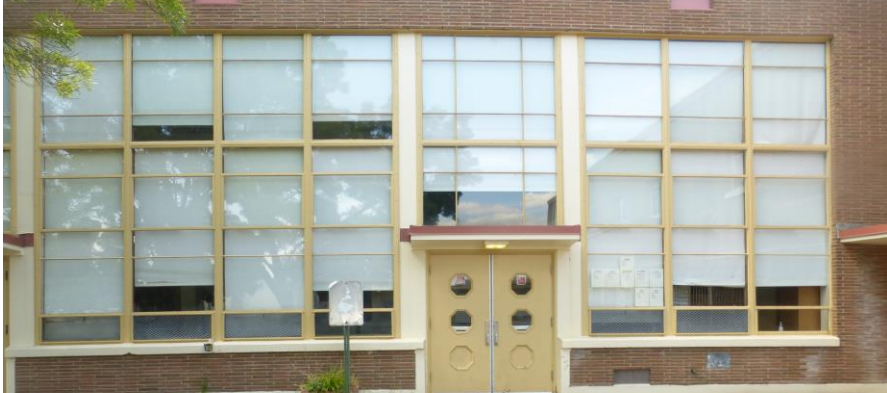
Typical cafeteria windows

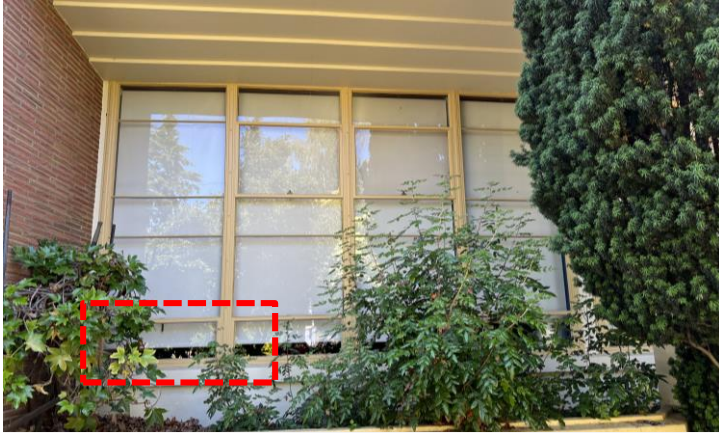
Office combination windows

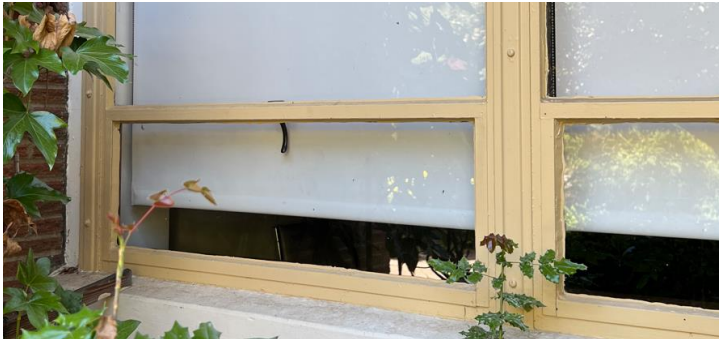
Close-up view of an office combination window

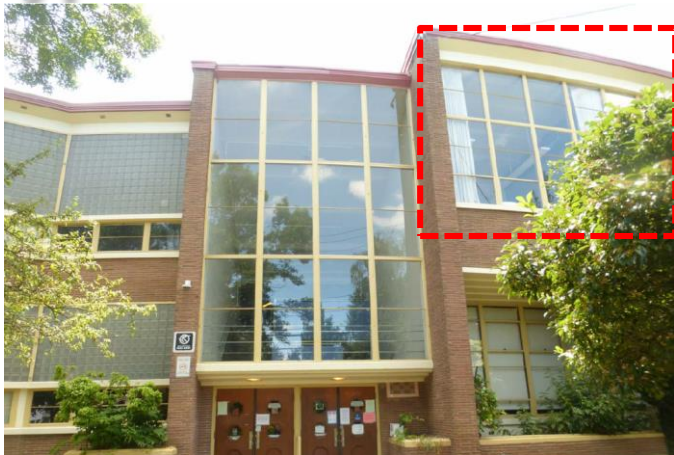
Red dashed area indicates library windows

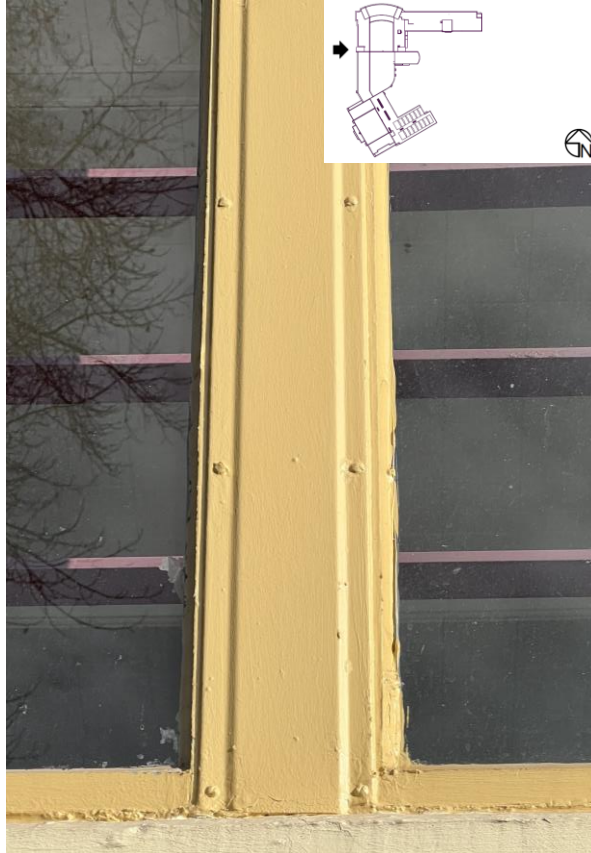
Wider steel mullions at stairwells

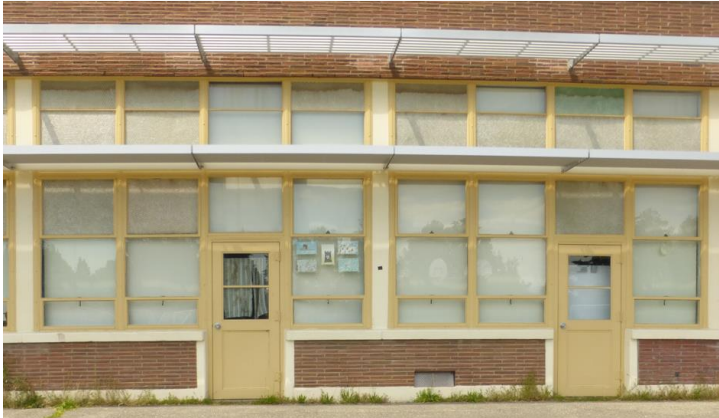
Steel windows and doors

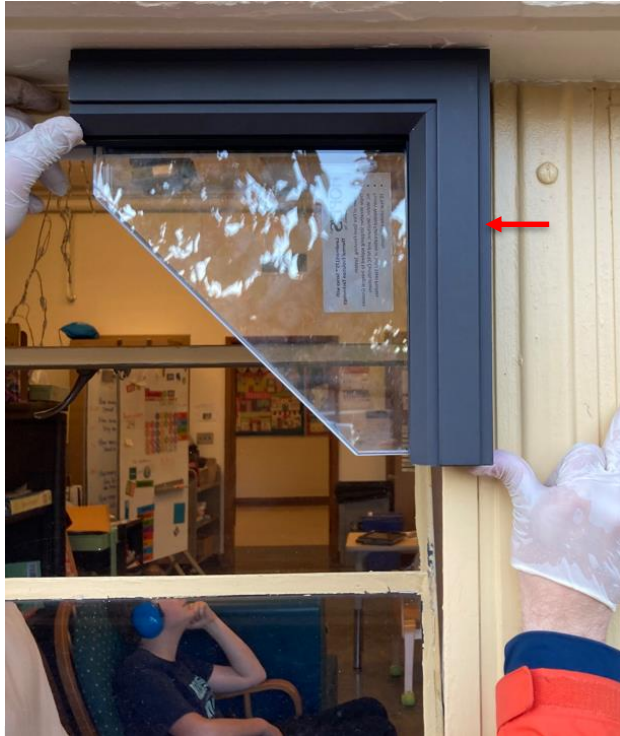
Photo above depicts a corner sample of Landmark 175 in operable profile adjacent to an existing operable window. *Note: The red arrow points to the location of steel flange that is missing on this sample, but will be included in the installed product to match existing conditions.*
